"FIFTY BELOW"

Operating an Autogiro in the Antarctic : The Report of a Pilot Attached to the Byrd Expedition

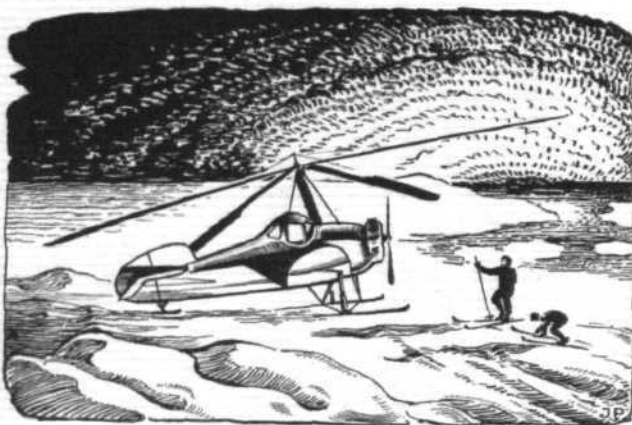
An early Kellett cabin Autogiro, of the type used on the Byrd expedition.
